**KENNEWICK SCHOOL DISTRICT**  
**1315 BUILDING RENOVATIONS**  
1315 WEST 4TH AVENUE  
KENNEWICK, WA 98336

**ROOF DEMO PLAN**

**MD6.1**

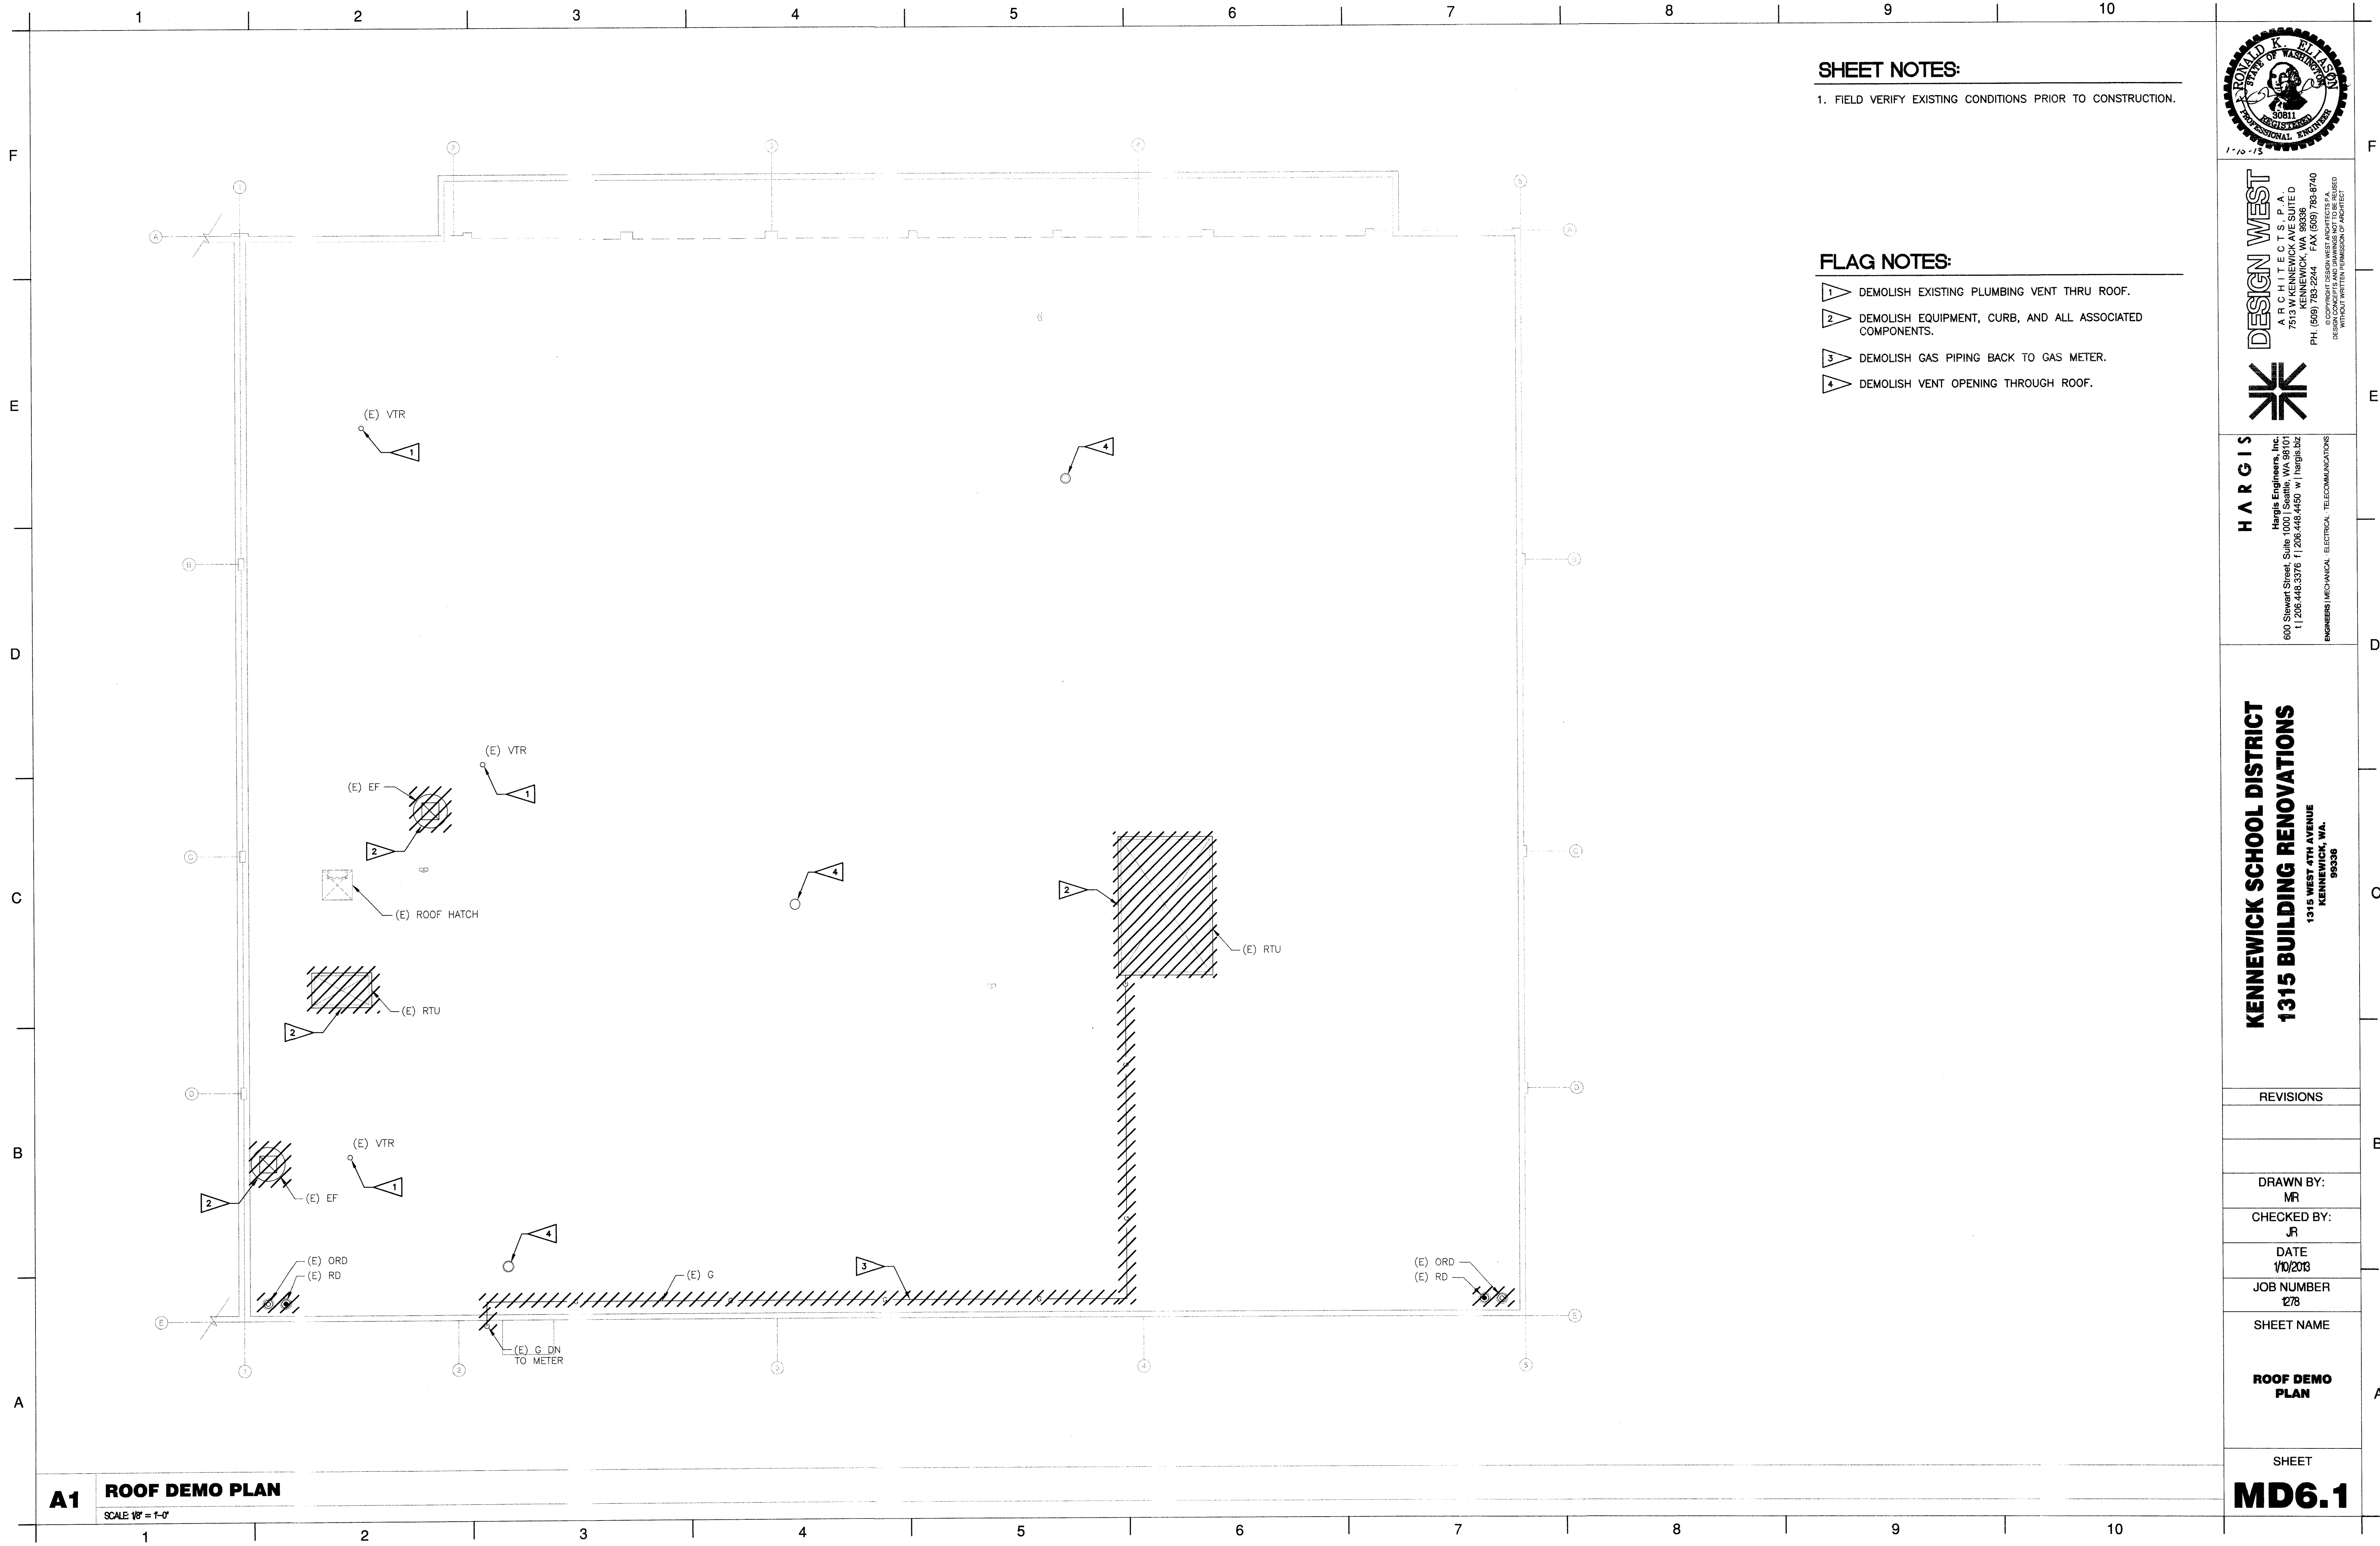
1. DEMOLISH EXISTING PLUMBING VENT THRU ROOF.  
2. DEMOLISH EQUIPMENT, CURB, AND ALL ASSOCIATED COMPONENTS.  
3. DEMOLISH GAS PIPING BACK TO GAS METER.  
4. DEMOLISH VENT OPENING THROUGH ROOF.
